STATE OF ILLINOIS  
ENVIRONMENTAL PROTECTION AGENCY  
DLPC/RPMS INSPECTION DOCUMENT

Site Code: 0938070003 -- Kendall County  
City/Site Name: Oswego/Saw-Wee-Kee Park  
USEPA ID: 984839159  
File Category: Superfund Technical Reports

Date: March 31, 1993 Time: From: 10:30 a.m.  
To: 12:00 p.m.

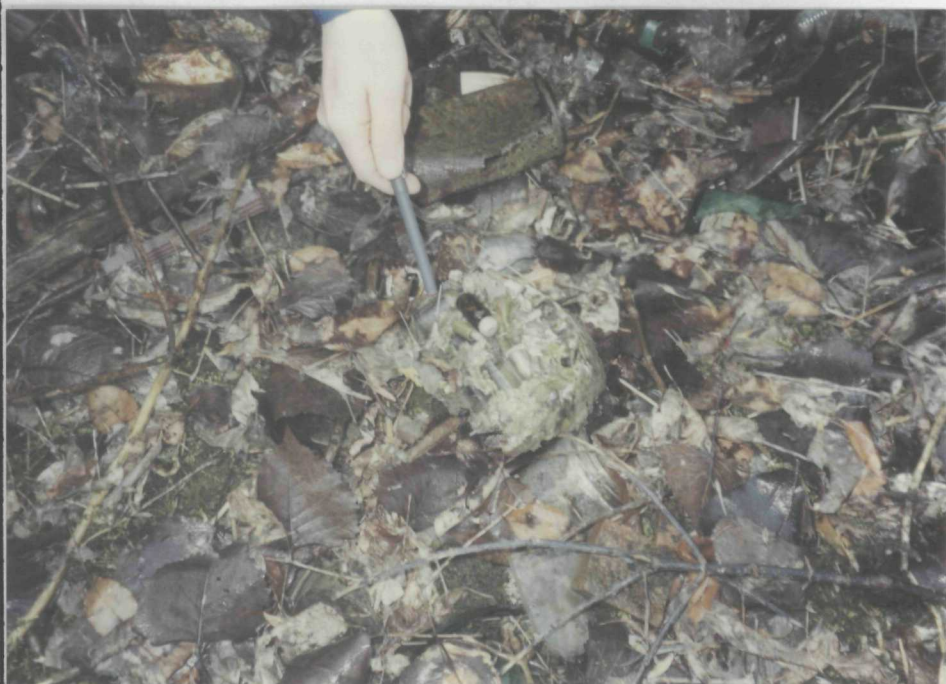
DATE: 03/31/93
TIME: about 10:46am
PHOTOGRAPH TAKEN BY: Marc Cummings
COMMENTS: Pictures taken toward: the west. This is a picture of the item in photo #1, but from a different angle.
ROLL #: 1      PHOTO #: 2

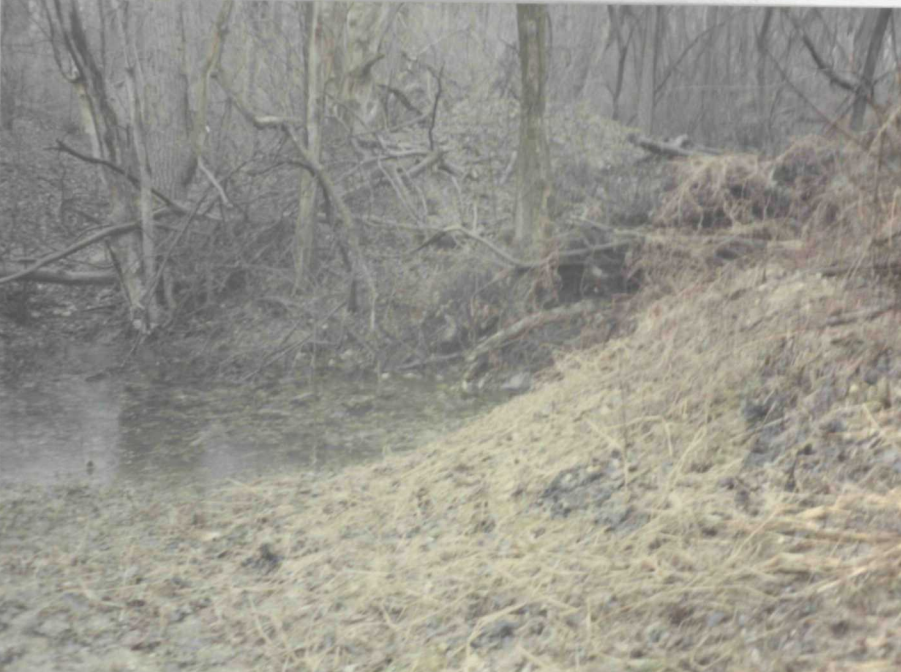
COMMENTS: Pictures taken toward: the east. This is a picture of a former drum burial (storage) area.	
ROLL #: 1 PHOTO #: 3

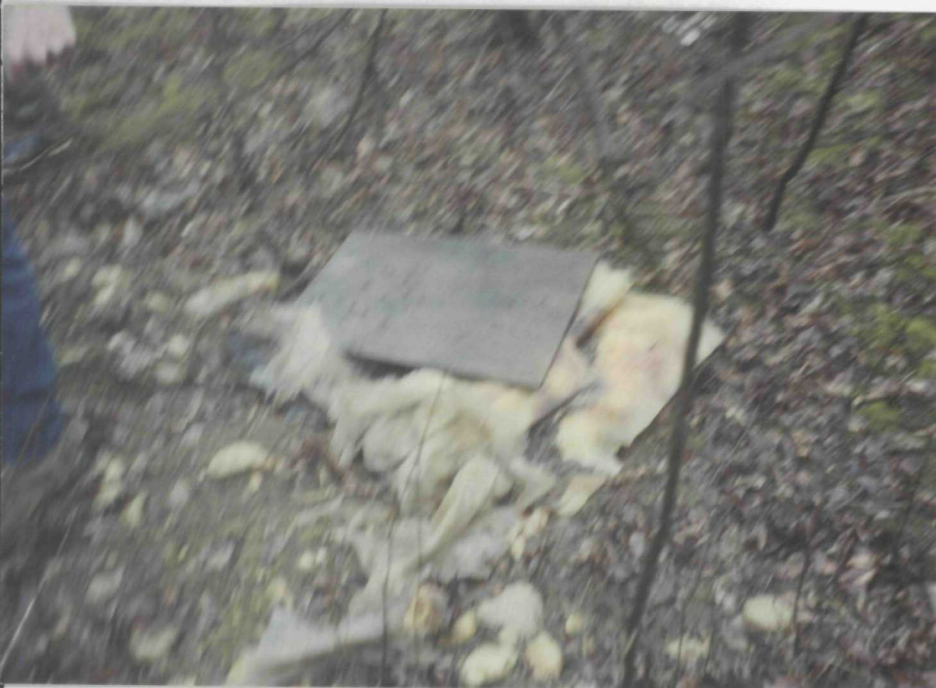
Narrative continued: citizens pointed out that this part of the Site had also been used as a dump and municipal and industrial was buried as shallow as 20 feet. We came to the edge of the Site property and then crossed the on-site road to begin looking at the an area of the Site known to have been the main area (about 12 acres in size) of past and/or continued dumping (Attachment 3 is a summary of Site history). In this area a large variety of surface trash was observed ranging from beverage cans and bottles, pieces of plastic, vacuum cleaner parts, rusted drums protruding from what appear to be man-made earthen mounds, loose bales of wire fencing, car body parts (fenders, bumpers, doors, etc.), and an unknown quantity of medically related items including an approximately eight (8) inch diameter piece of resin-like material containing used needles and medical vials. The piece of resin-like material containing medical waste was picked up by Louise Fabinski of ATSDR and photographed by Jeff Larson and myself (see attachment 4). A buried drum was observed a drum buried in an earthen mound and covered with pieces of plastic and a piece of plywood. The Agency sampled this drum on April 22, 1992 finding that the liquid had a flashpoint of 95.30 F. An analysis of sample indicated the presence of toluene, ethylbenzene, xylenes, naphthalene, and 2-methylnaphthalene. This drum is located near a visibly used camping area.

DATE: 03/31/93
TIME: about 11:25 am.
PHOTOGRAPH TAKEN BY: Marc Cummings
COMMENTS: Pictures taken toward: the southeast. This is a picture of a covered buried drum, sampled by the IEPA in 4/92.
ROLL #: 1 PHOTO #: 4
